<b>Title:</b>	<b>FIGAS – Funding for Replacement Aircraft (VP-FBM)</b>
<b>Paper Number:</b>	08/19
<b>Date:</b>	30 <sup>th</sup> January 2019
<b>Responsible Director:</b>	Director of Development & Commercial Services
<b>Report Author:</b>	General Manager, Aviation Services
<b>Portfolio Holder:</b>	Honourable MLA Elsby
<b>Reason for paper:</b>	This paper is submitted to Executive Council:  For information and approval
<b>Publication:</b>	Not Recommended:  <i>Under Executive Council Standing Order 23(2), Executive Council must have regard to the categories of exempt information in Schedule 3 to the Committees (Public Access) Ordinance when determining if information should be withheld</i>  <i>The categories which are potentially relevant to this paper are:</i>  Paragraph 10 - Information about relevant contracts and negotiations
<b>Previous papers:</b>	Review of Aviation Services 224/15 FIGAS – Pilot training capacity 12/18 Additional Funding for Aircraft Engines 09/18 FIGAS – Funding for Additional Airframe 55/18

Report No. **DOR-BN2-0840**Issue No. **A**Title. **Damage Assessment on Constructor No 2200 (Ref Reg VP-FBM)**

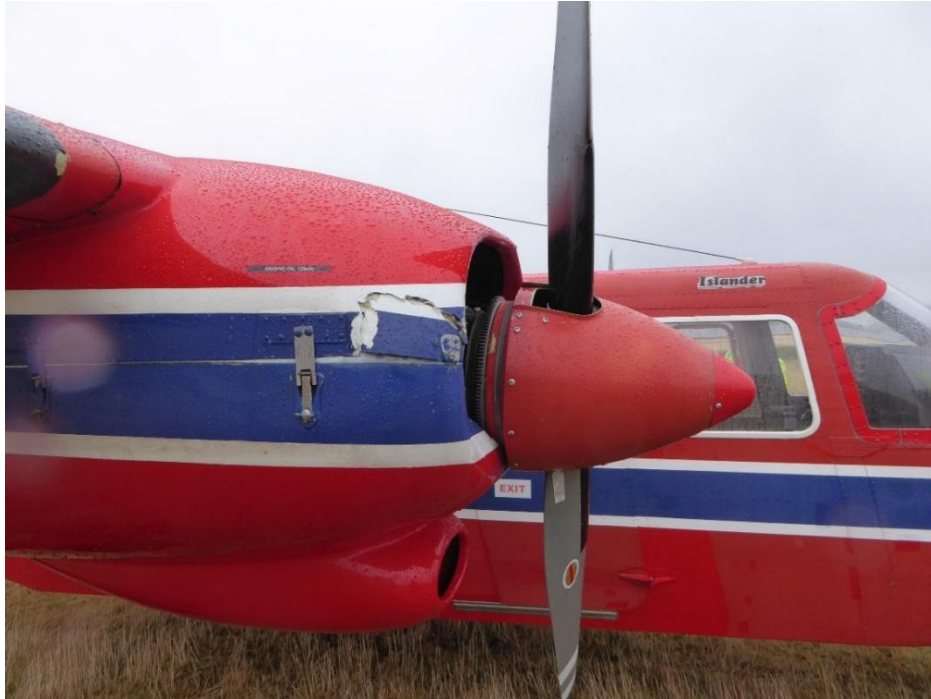
**Figure 1 - Side view looking on Starboard Engine**

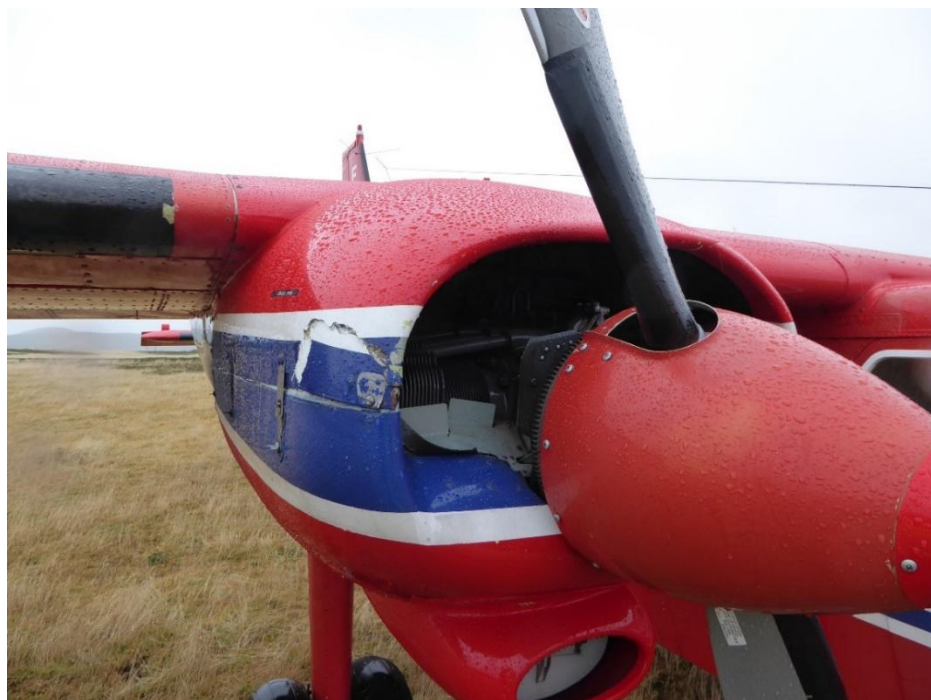
**Figure 2 - Front View Looking Aft on Starboard Engine**

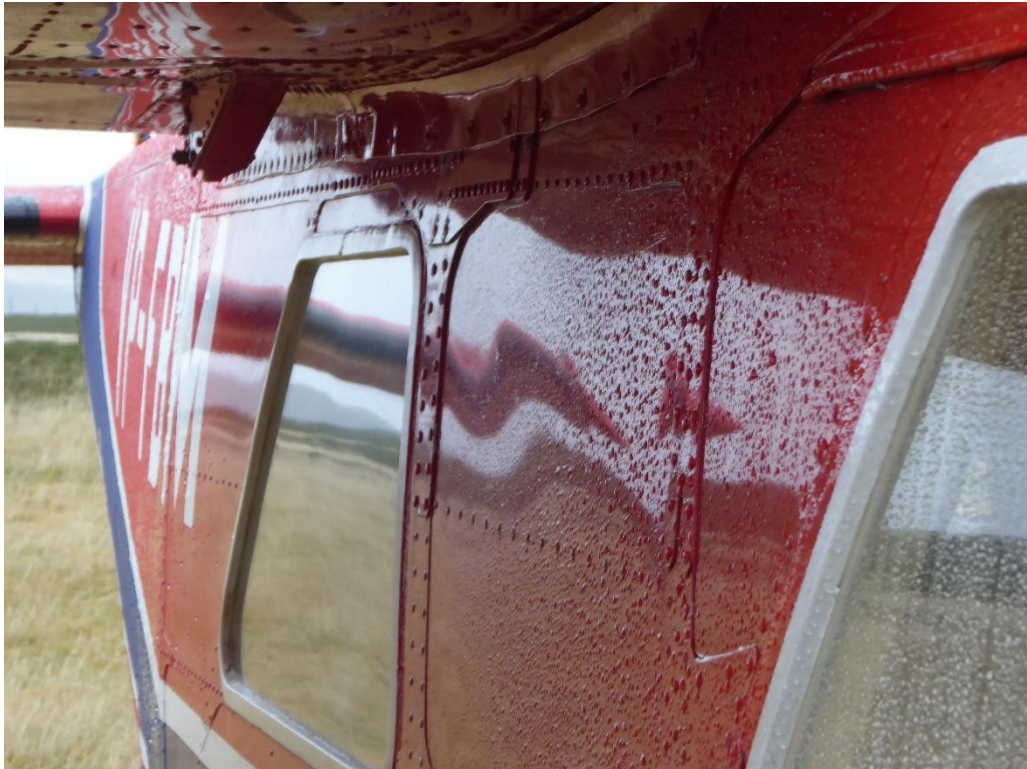
**Figure 3 - View on Starboard Side Fuselage under the wing – Prior to Moving aircraft**

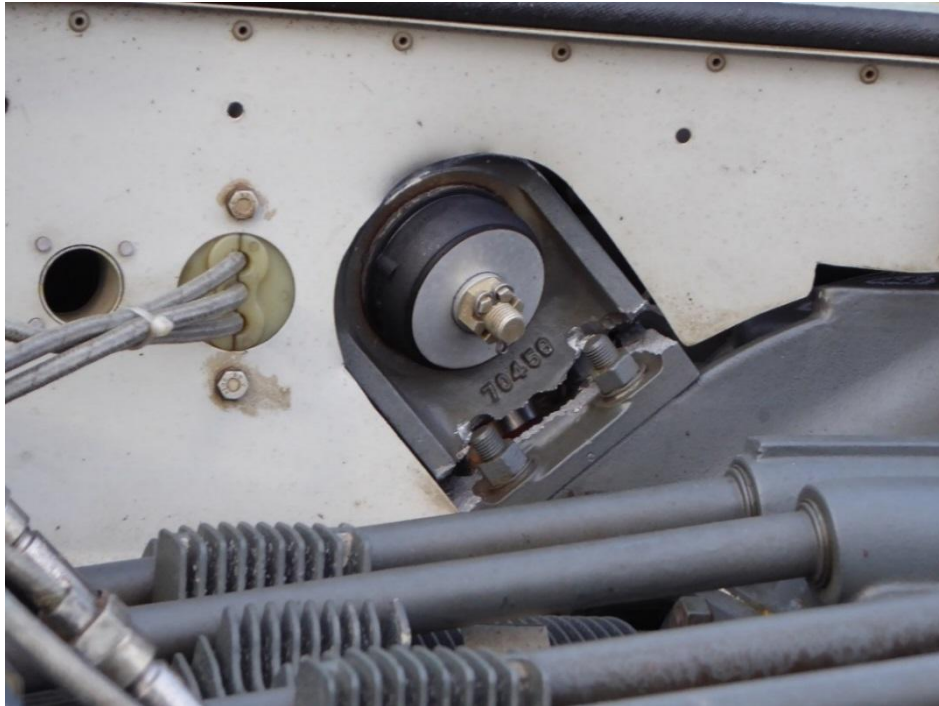
**Figure 6 - View looking on Starboard Outboard Upper Starboard Engine Mount**

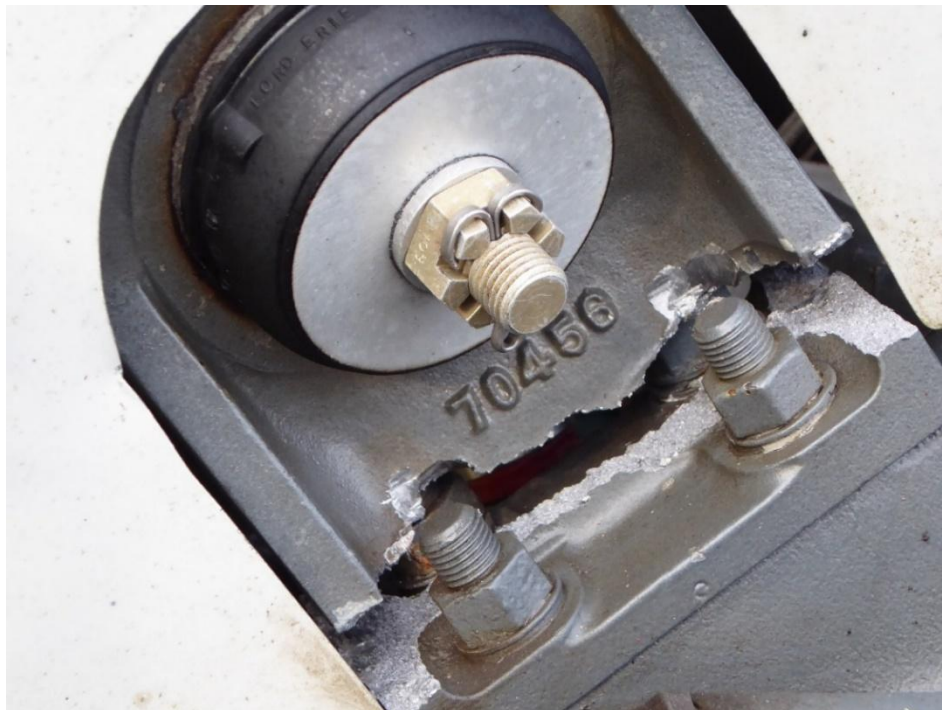
**Figure 7 - Close up view looking on Starboard Outboard Upper Engine Mount**

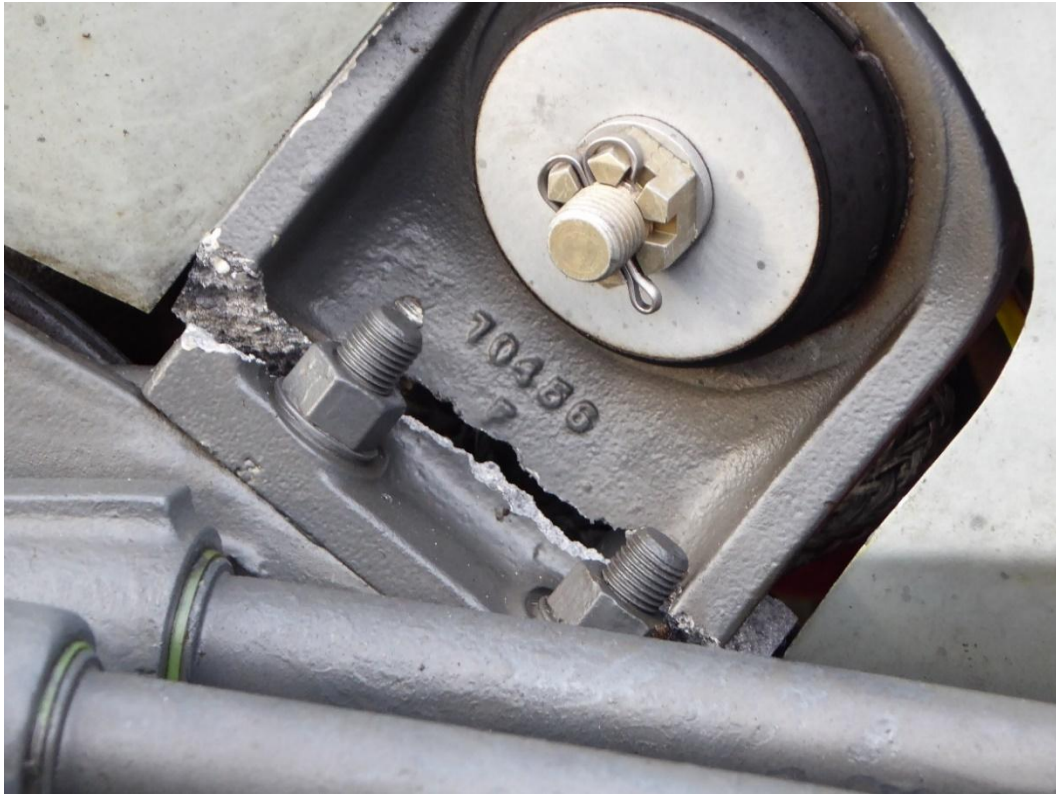
**Figure 8 - Inboard Upper Starboard Engine Mount – Close up**

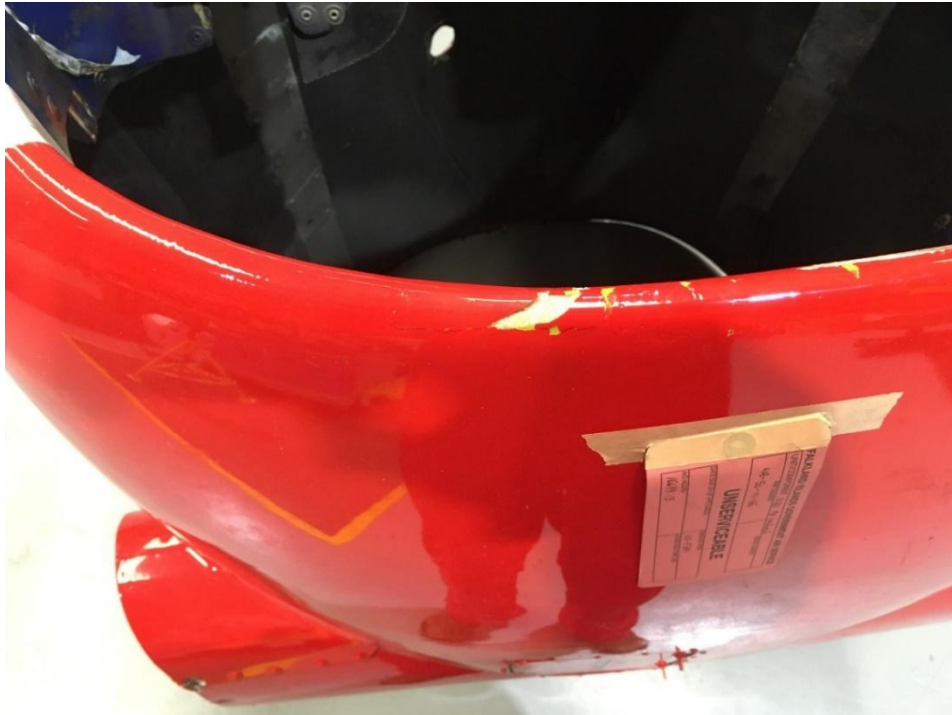
**Figure 13 - Looking Aft On Top – starboard Engine Cowling**

5.1.30		Starboard Lower Engine Cowling	The cowling should be replaced.
5.1.31		Port Lower Engine Cowling	OK to install
5.1.32		Starboard Upper Engine Cowling	There is a large hole, so the cowling should be replaced.

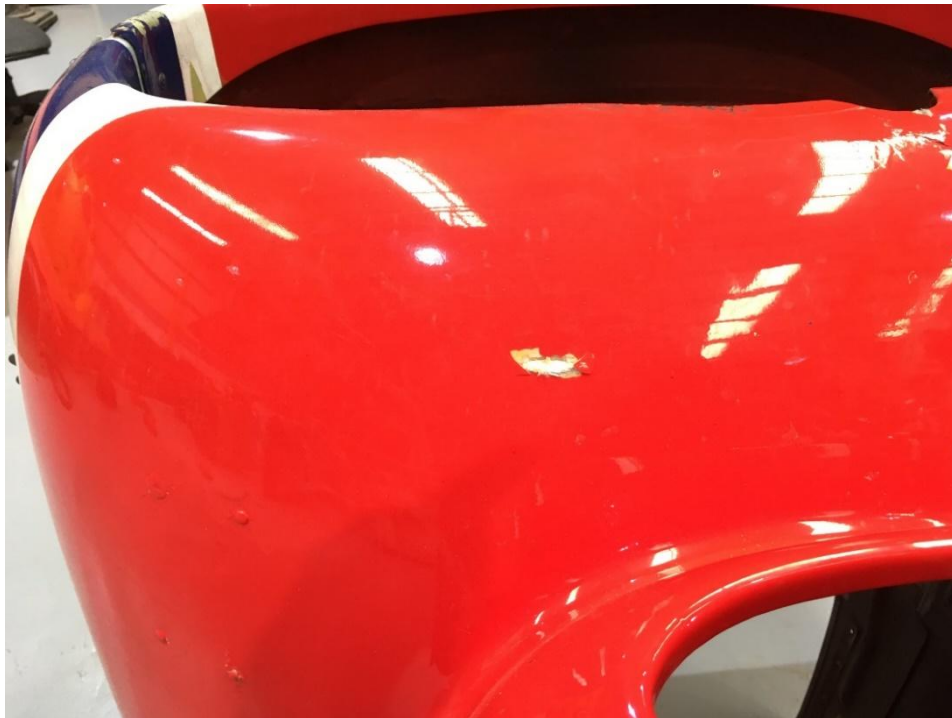
**Figure 18 - Close up view looking up on the starboard lower engine cowl**

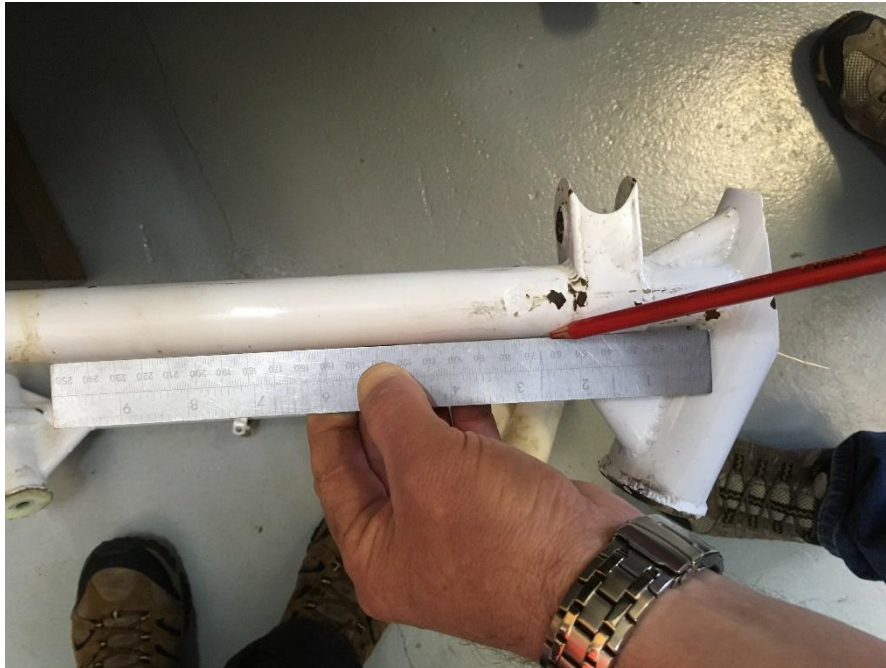
**Figure 22 - Engine Frame**

5.1.21	NB-20-5231	Starboard Engine Frame	This engine frame looks ok, however this is on the side of the aircraft with the extensive wing damage and will need to be replaced.

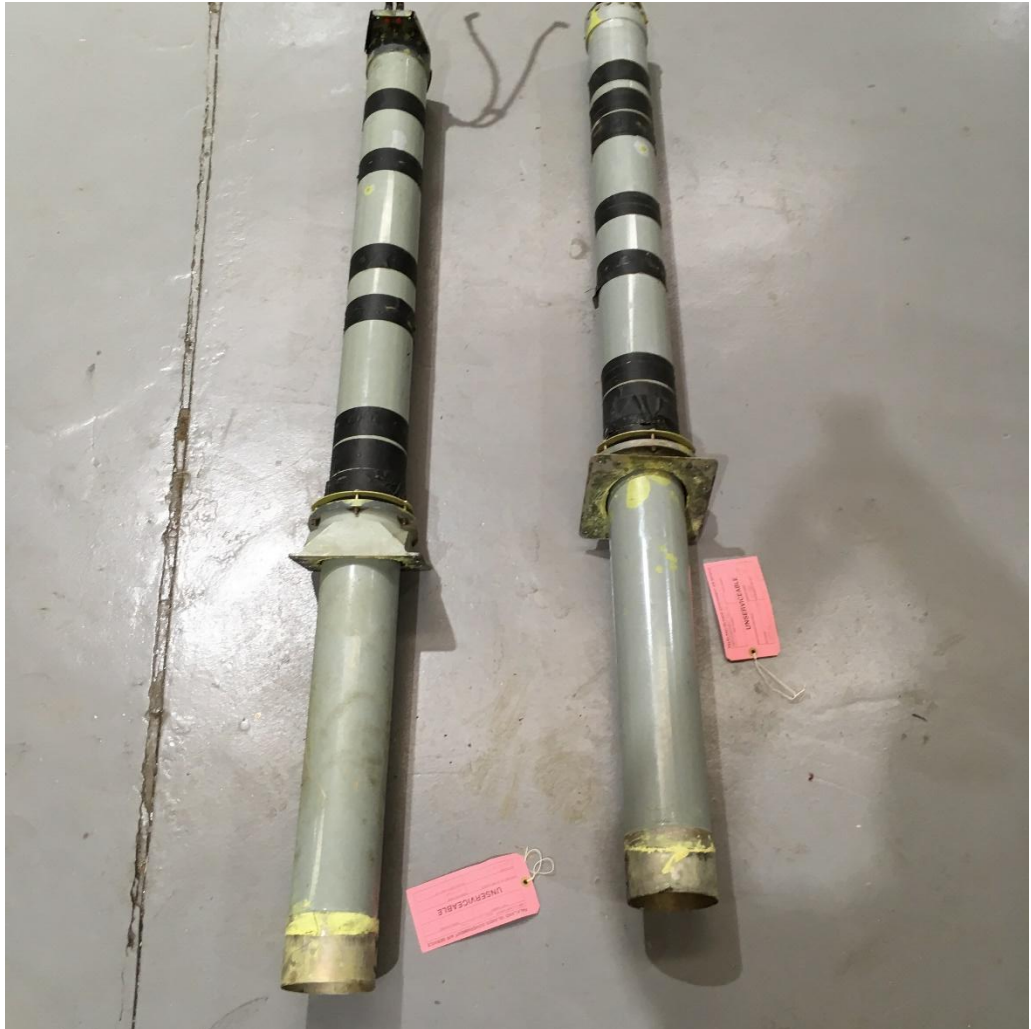
**Figure 23 – Undercarriage Leg tubes**

The damage to the landing gear and associated engine frame on the port and starboard side requires repair by replacement. In addition a significant number of primary structural components would have to be replaced.

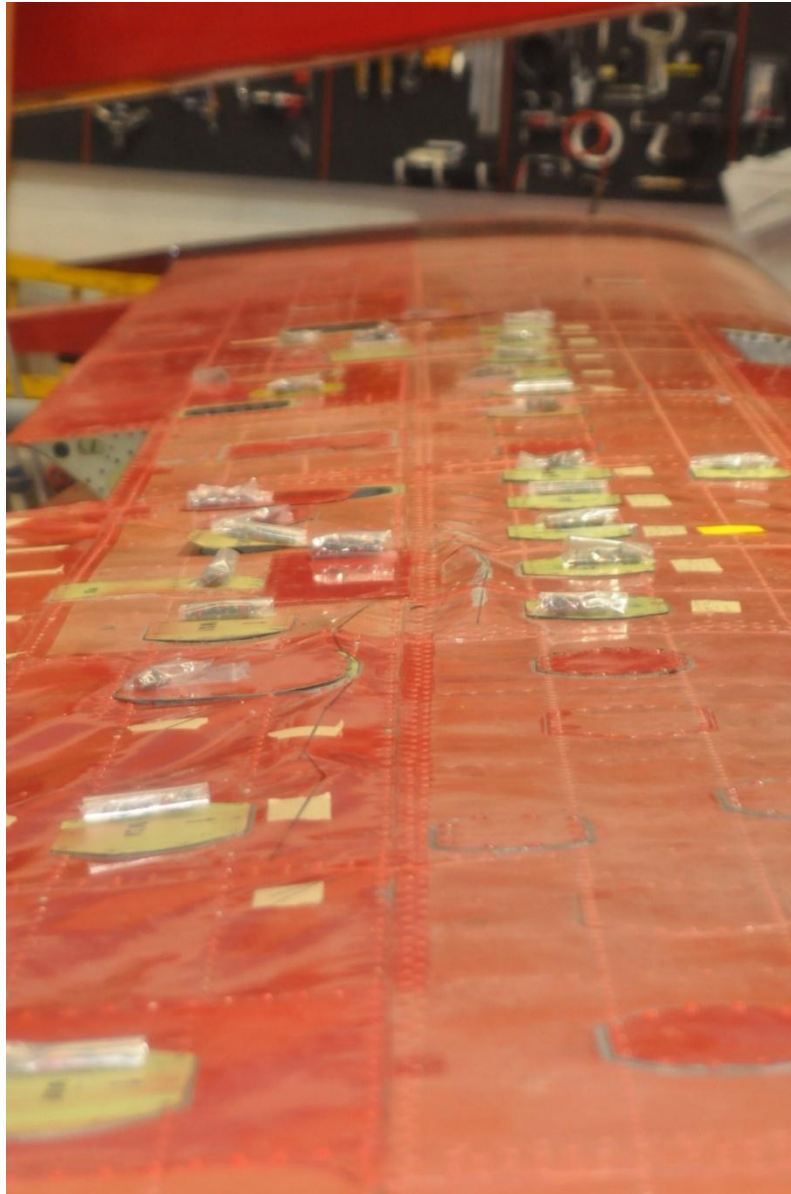
**Figure 24 - View along the top surface of the wing showing the Rear Spar Curve**

To remove the damage on the wing, the rear bay of the wing would need to be repaired with most of the ribs replaced, from where the outboard section of the starboard flap starts to the outboard section of the port flap ends. In the primary structure many, if not all of the ribs in between the spars, would have to be replaced from the starboard outboard flap to the inboard section of the starboard flap. When the wing is apart some of the leading edge ribs would also need to be reformed or replaced.

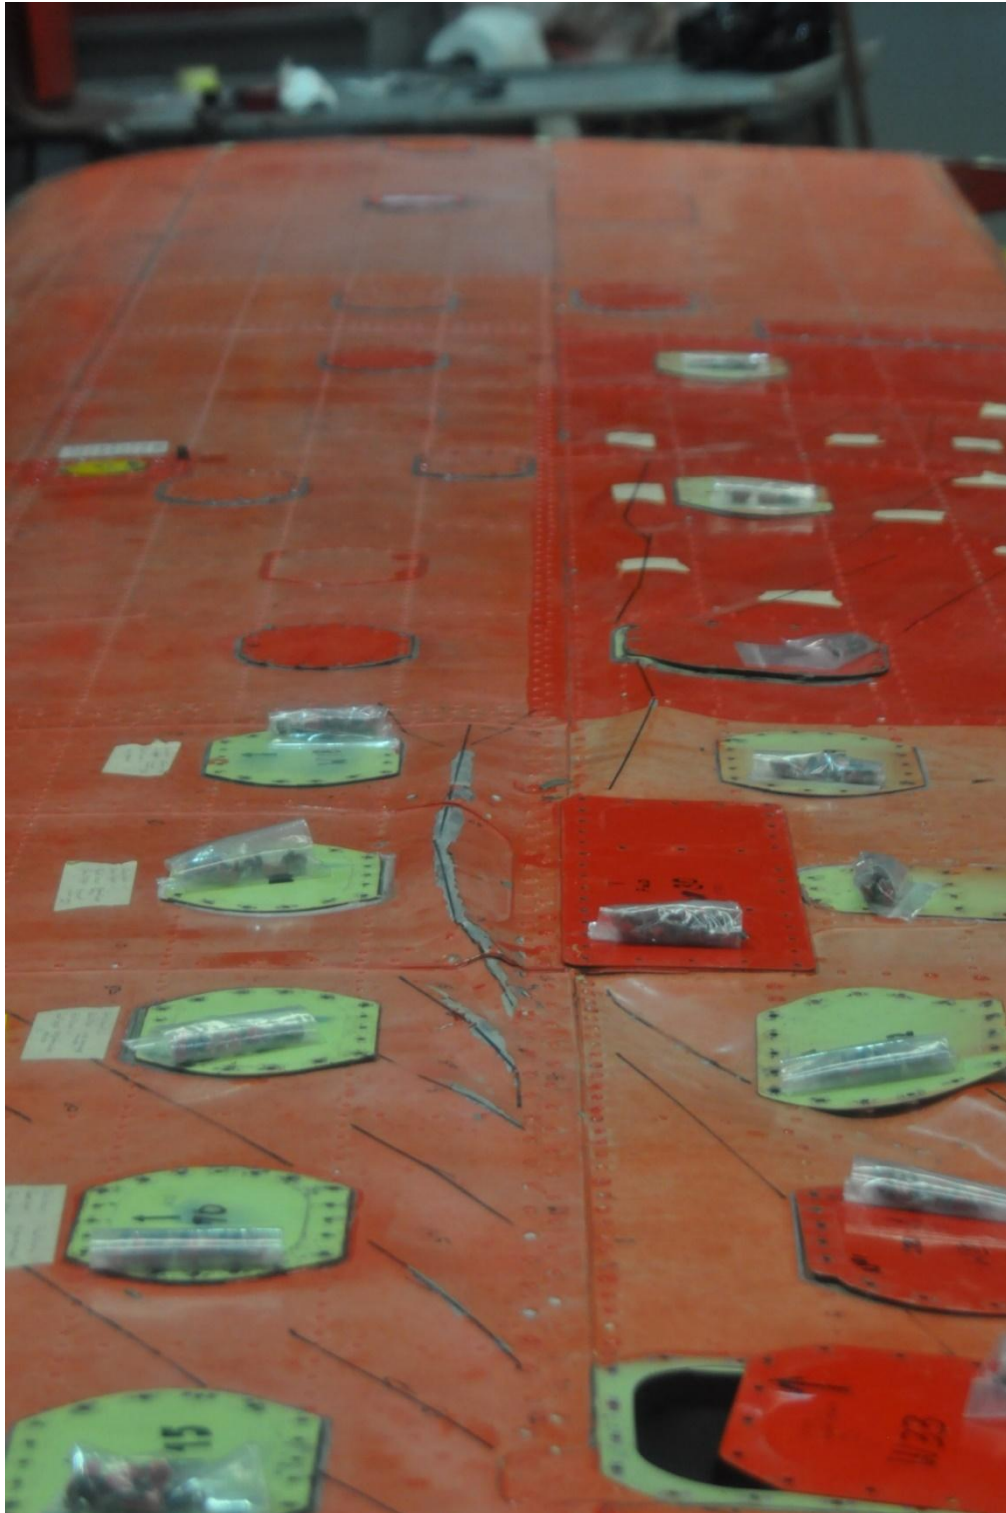
**Figure 27 - Starboard Side Looking Outboard.  
The pen lines are showing the high points of skin rippling.**

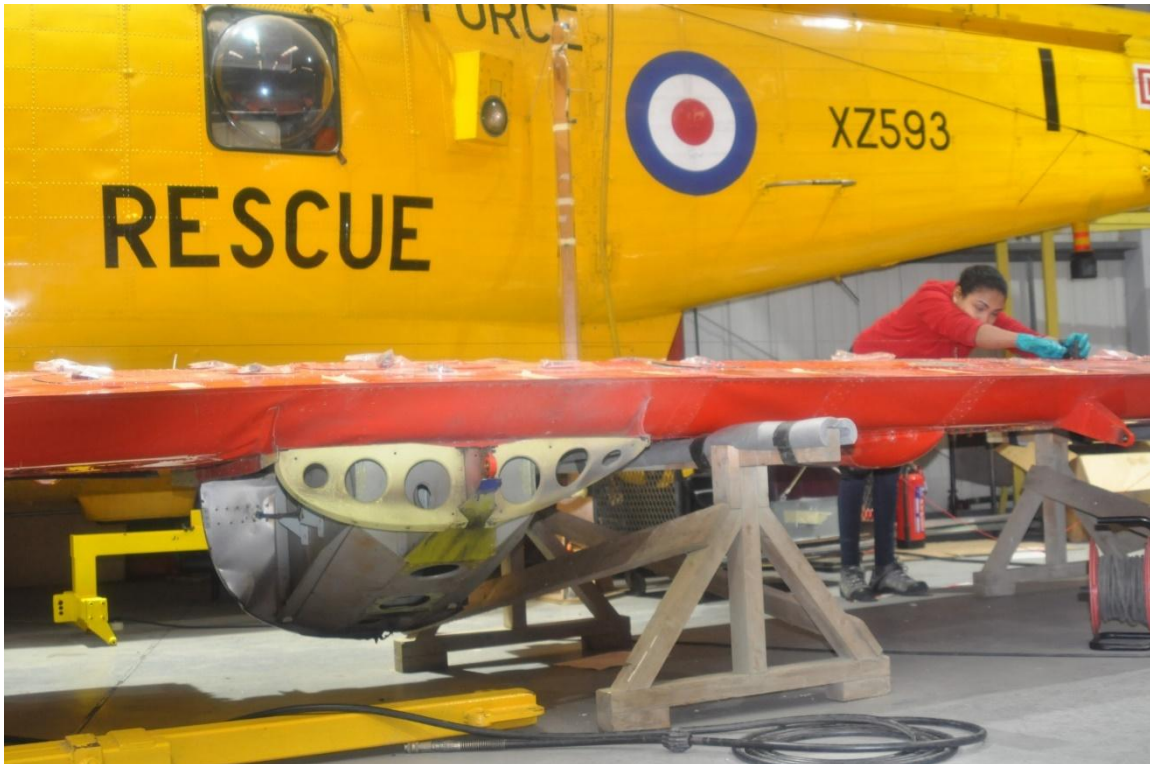
Figure 36 - Starboard Rear Bay / Nacelle- showing the bow in the top of the wing

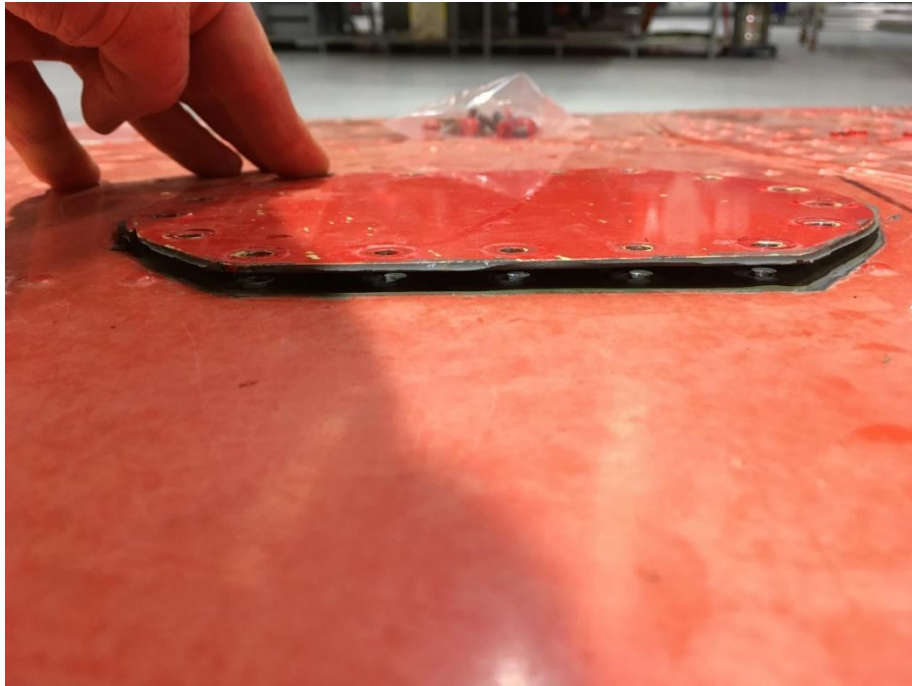
**Figure 42 - Wing Panel W12 port side of the centre line is no Longer Flat**

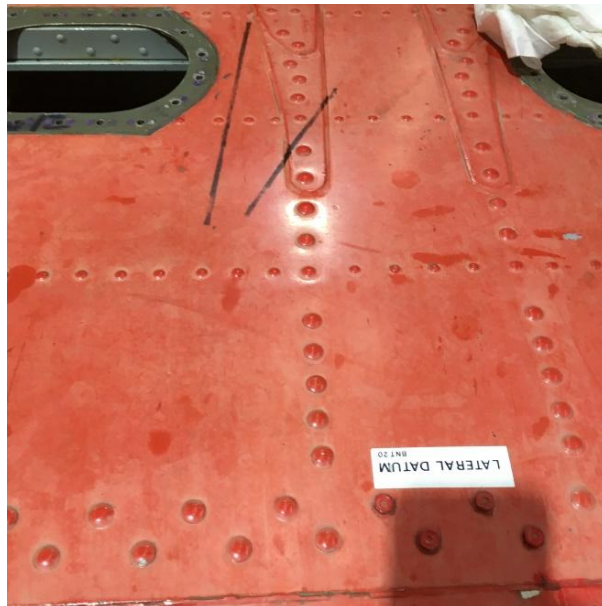
**Figure 43 - Port Forward Wing to Fuselage Forward Pick Up Point signs of movement**

The Port side of the wing has sustained damage but is much more subtle. The nacelle lower angles have bent this is consent with nacelle taking more load than it should, due to the leg moving. It would be recommended that the nacelle is replaced. It should be noted that the structure has stretched beyond its original shape. For example there is a forward to aft bulge in line with the outer edge of the flap. This side also has a bulge at the forward wing to fuselage pickup point.

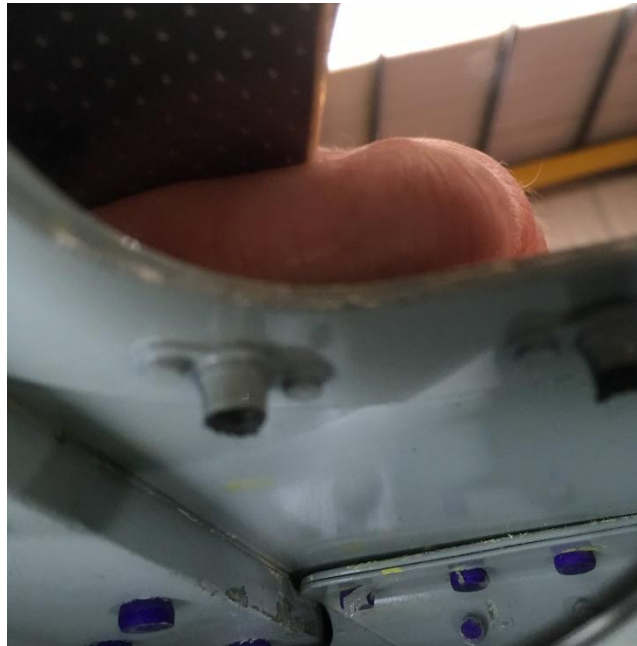
Figure 45 - View looking under W14 – The rib is damaged and not touching the skin

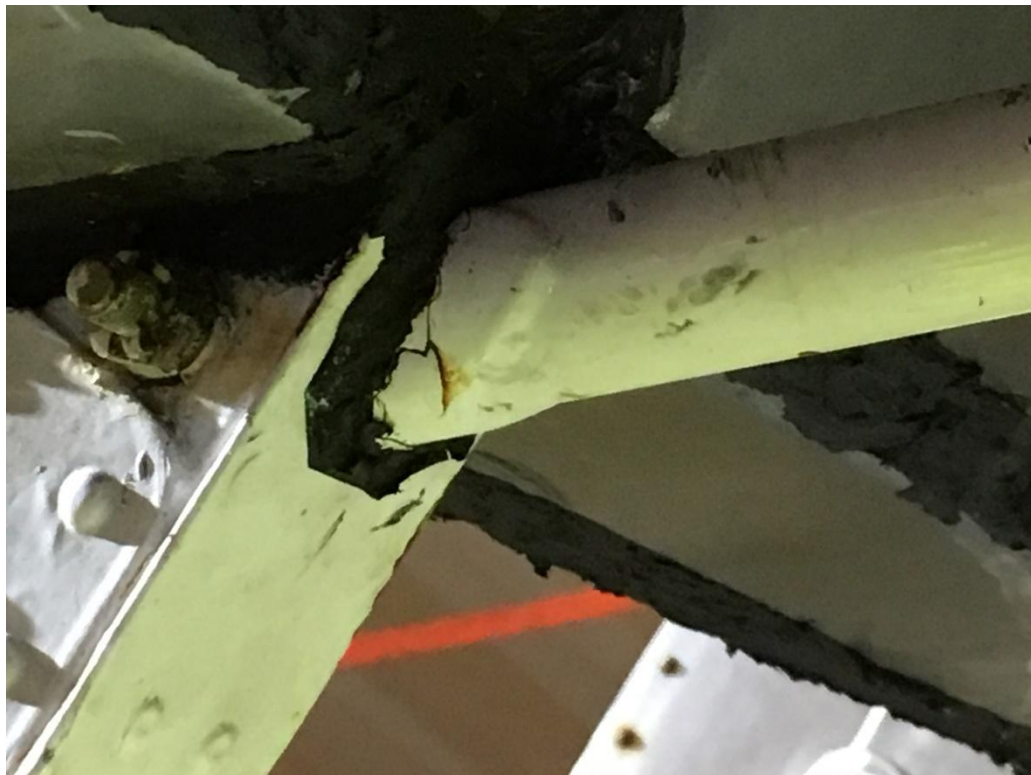
**Figure 47 - View on Engine Frame Upper Mount Paint Cracking**

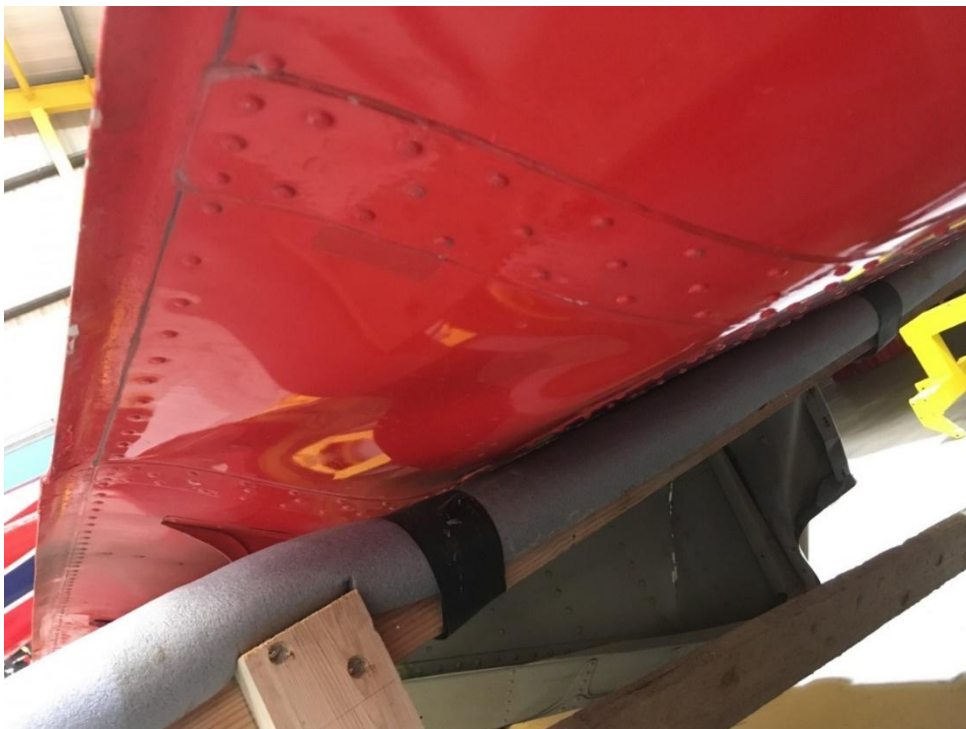
**Figure 53 - Starboard side twisted trailing edge**

However, on close inspection, it was revealed that a significant amount of wing twisting would need to be rectified. Due to the significant damage, the wing will need to be placed in a production jig to ensure correct alignment.

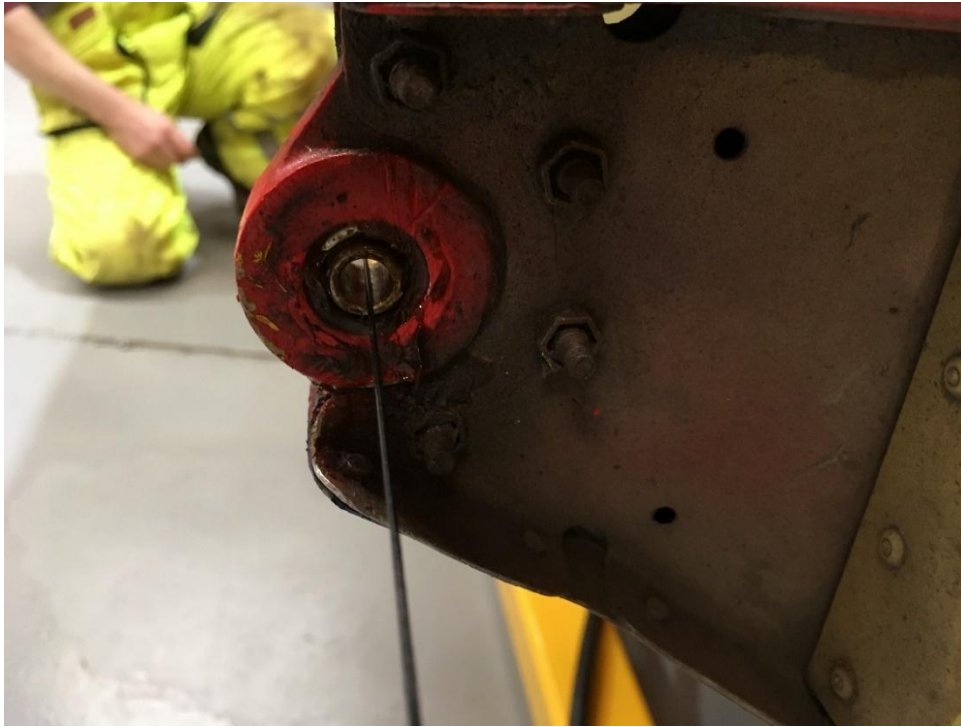
Figure 54 - Starboard Side Flap Middle Hinge Point is no Longer Aligned

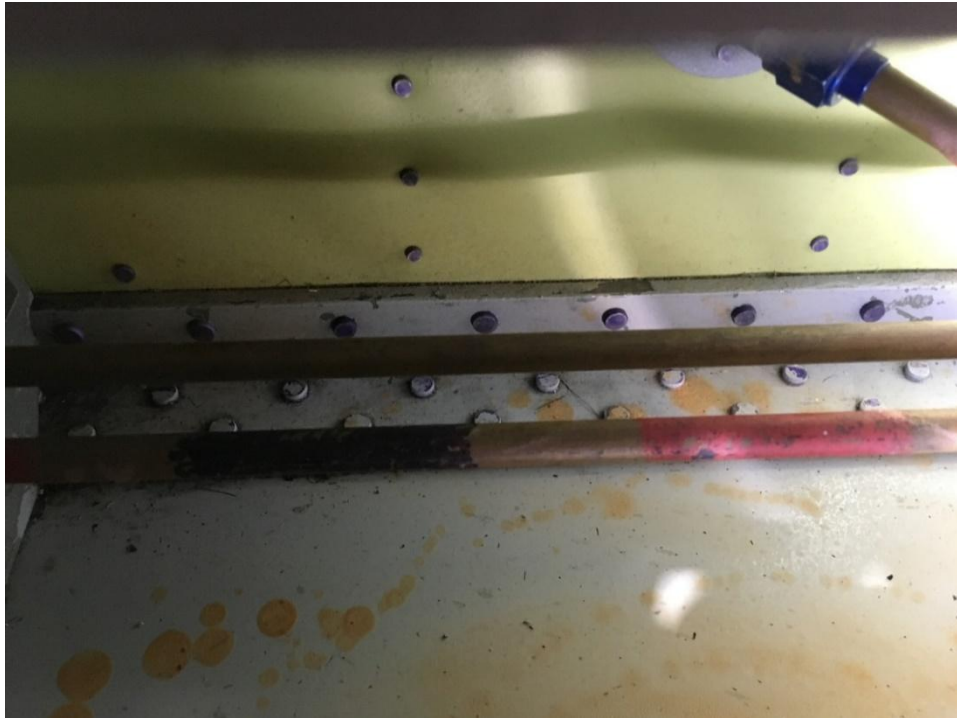
Figure 56 - View looking on an example of paint cracking on a lamination

An inspection along the wing for SB237. In areas where the paint is flaking of the spar caps have become delaminated they will have to be repaired.

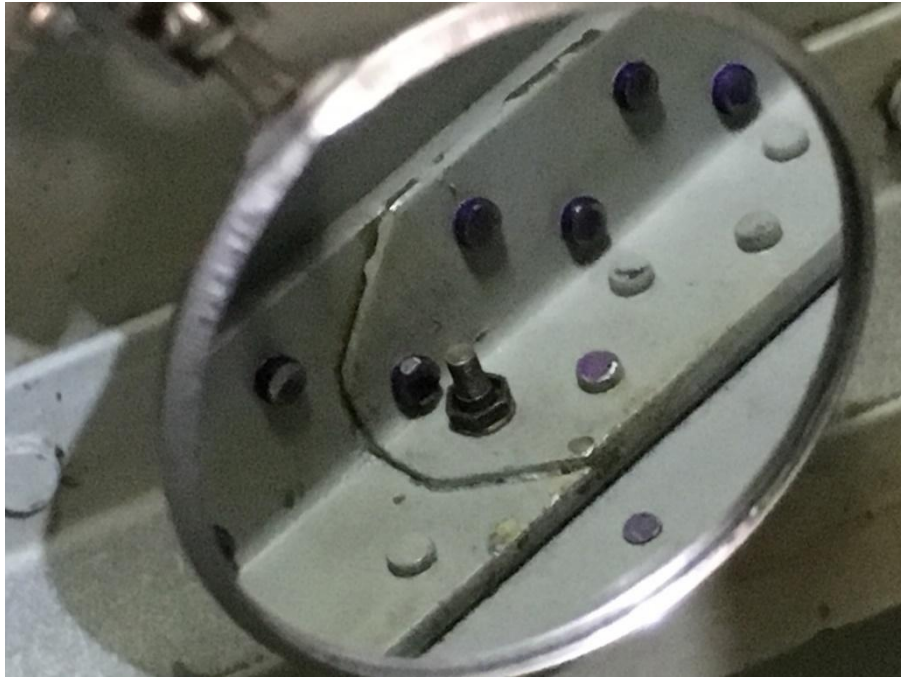
**Figure 58 - View looking on capping – paint cracking – possible movement between the lamination**

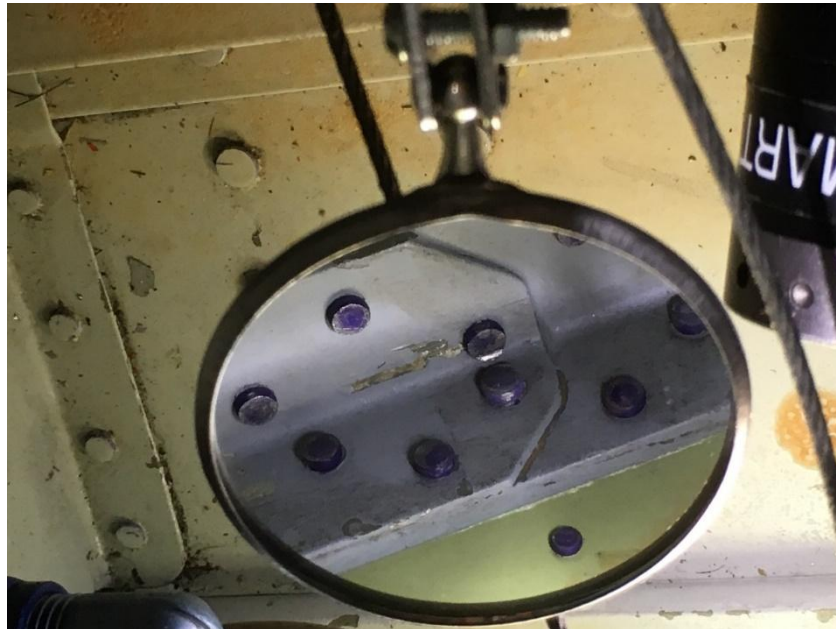
**Figure 59 - View looking on capping – paint cracking – possible movement between the lamination**

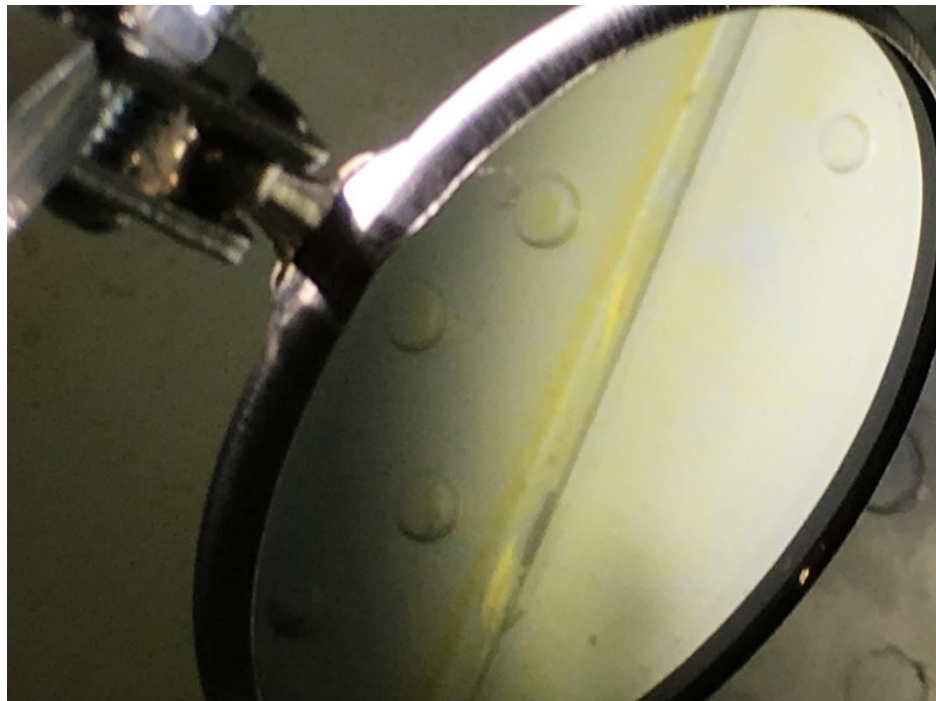
Figure 61 - View looking on capping – paint cracking

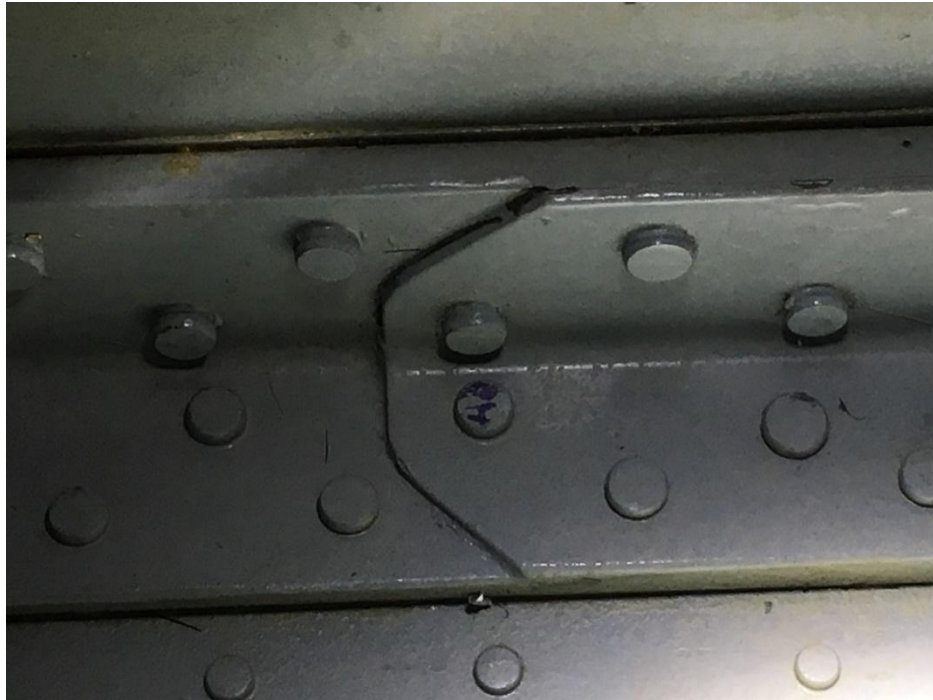
Figure 62 - View looking on capping – paint cracking – possible movement between the lamination

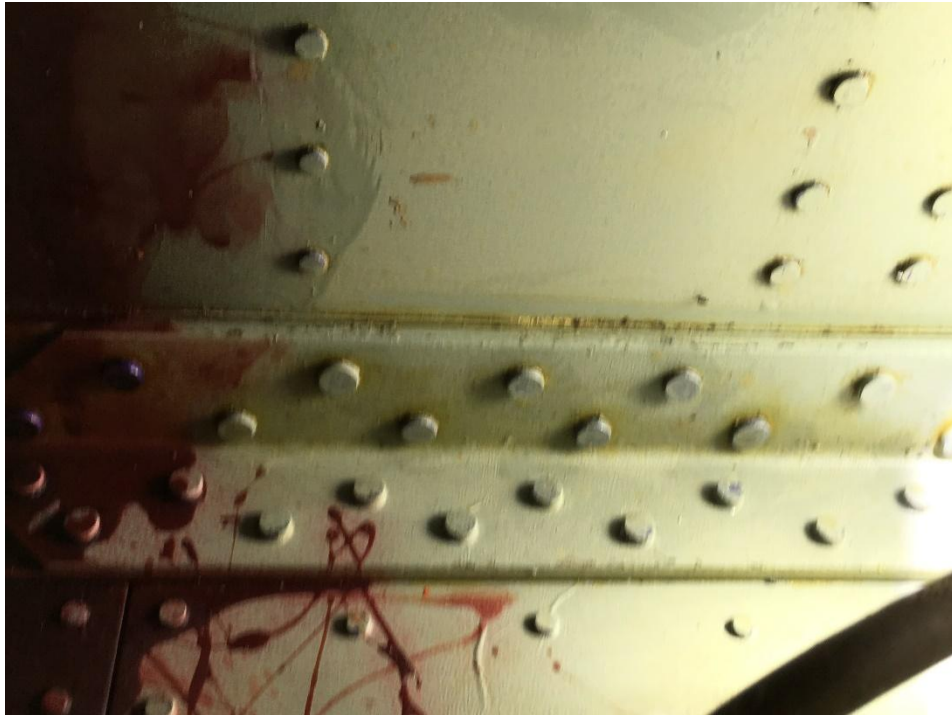
**Figure 66 - View looking on capping – paint cracking**

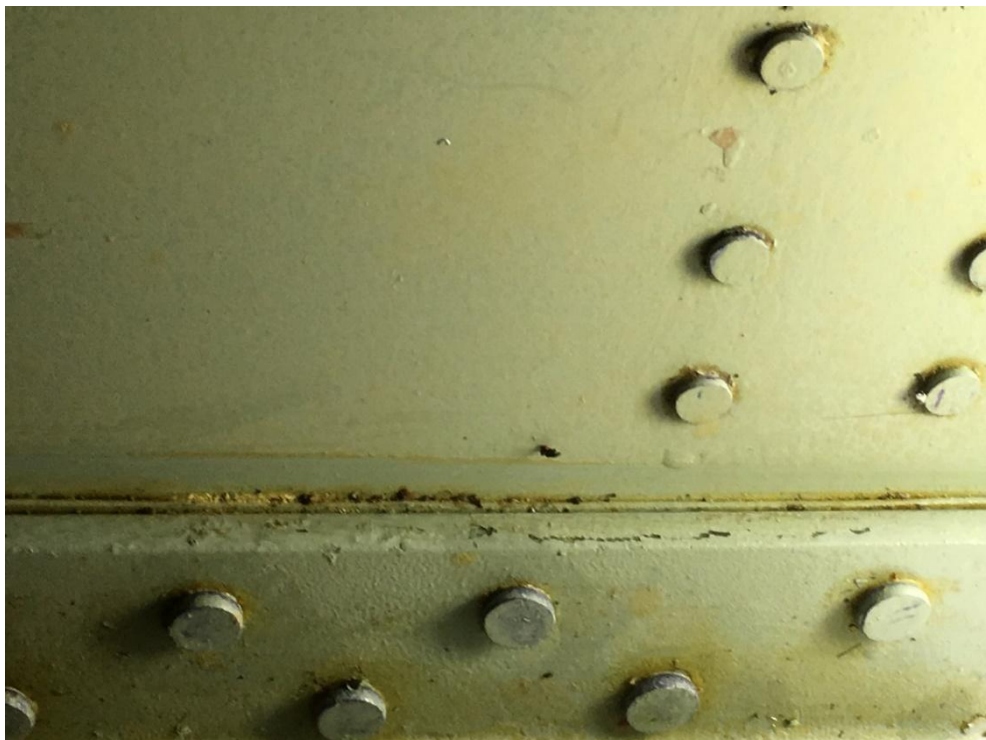
**Figure 67 - View looking on capping – paint cracking – possible movement between the lamination**

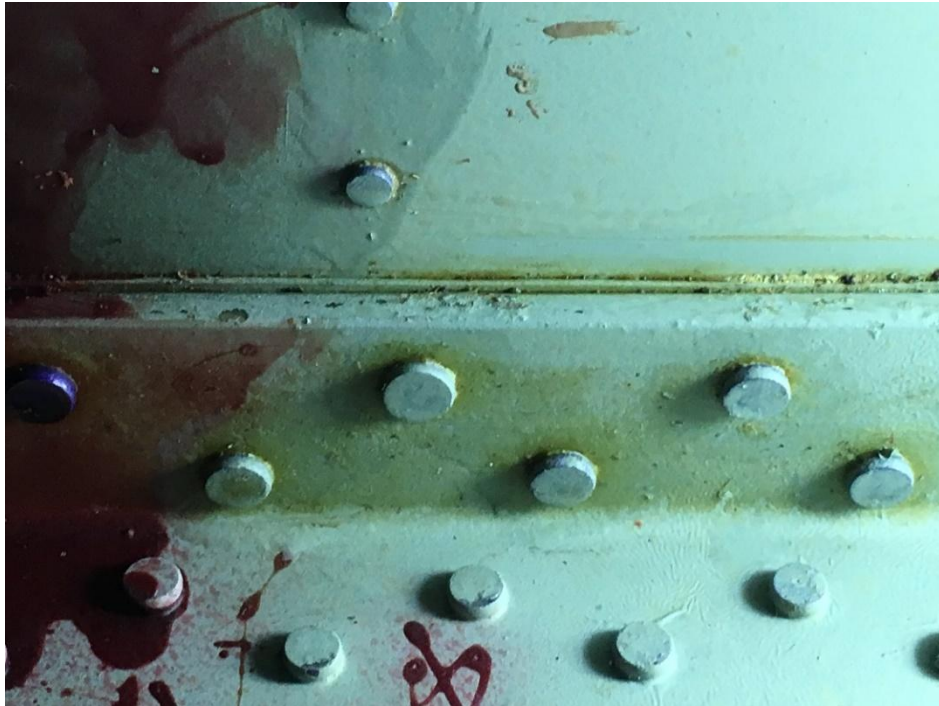
**Figure 68 - View looking on capping – paint cracking – possible movement between the lamination**

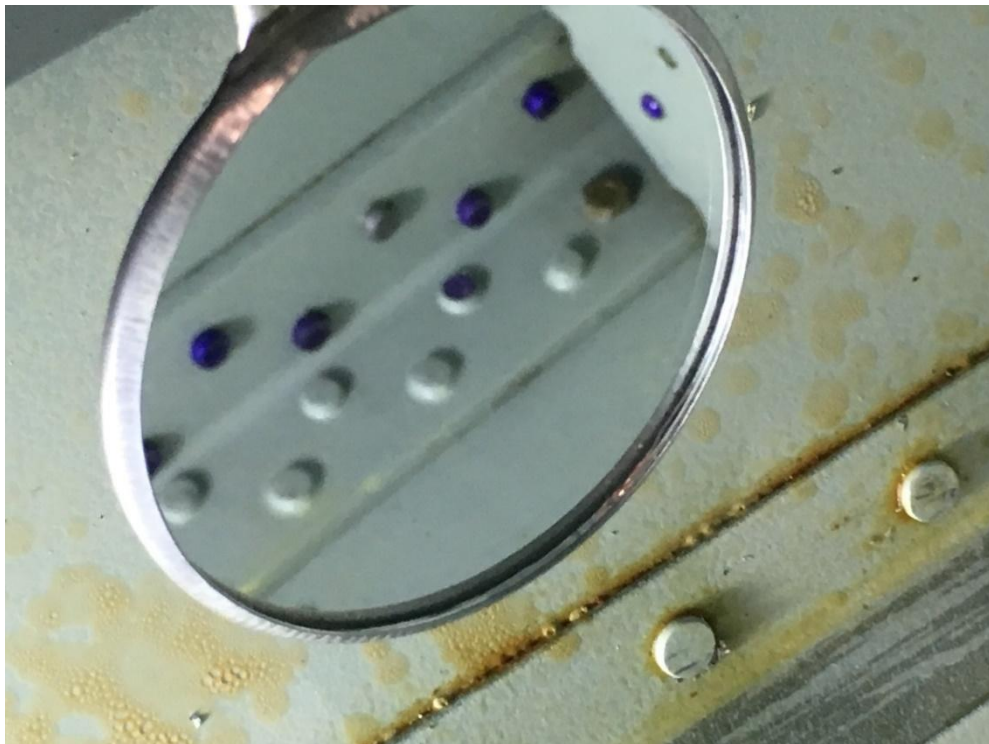
**Figure 69 - View looking on capping – paint cracking – possible movement between the lamination**
